# Manhole Inspection Summary

Manhole # S35AA\_006MH

Insp Date: **11/14/07 8:49 AM**

**Location** Address: **707 n.calvert**

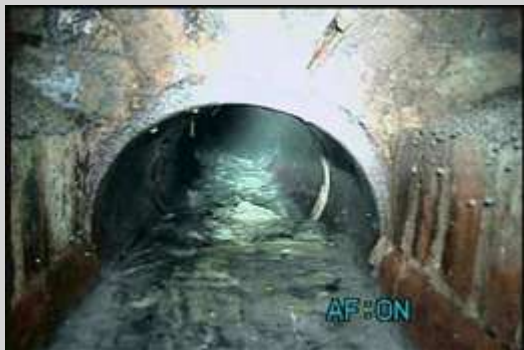
12 O'Clock Outflow

12 in. Circular Gravity Sewer  
Pipe Out @ 12 O'Clock

Pipe Material: **Clay** ☐ Pipe Lined

Invert Depth: **13.75** (ft.) Flow Characteristics: **Slow**

Deposits: ☒ None ☐ Mud ☐ Sludge ☐ Debris ☐ Grease

Infiltration: **None** Pipe Seal Cond: **Unknown**

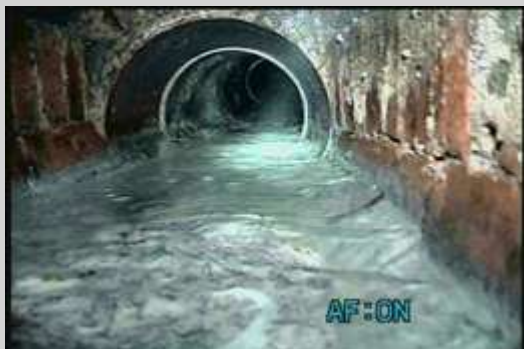
6 O'Clock Inflow

12 in. Circular Gravity Sewer  
Pipe In @ 6 O'Clock

Pipe Material: **Clay** ☐ Pipe Lined

Infiltration: **None** Pipe Seal Cond: **Unknown**
